# Manhole Inspection Summary

Manhole # S27G\_\_027MH

Insp Date: **6/21/08 9:18 AM**

**Location** Address: **16 S Poppleton**

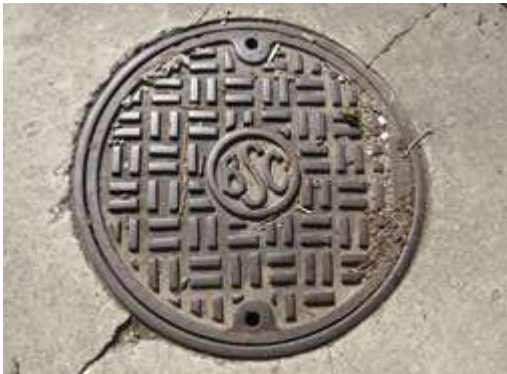
Cover View

Condition: **Sound**

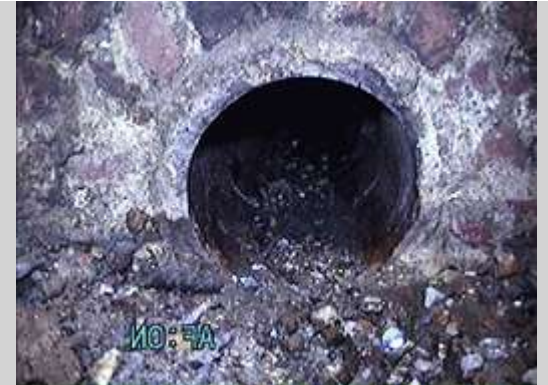
12 O'Clock Outflow

8 in. Circular Gravity Sewer  
Pipe Out @ 12 O'Clock

Infiltration: **None** Pipe Seal Cond: **Sound**
